Technical Inspection Report
Bureau of Ordnance Group

6
OPERATION CROSSROADS.

TESTS 'A' AND 'B'.
VOLUME IV.
PART X. PHOTOGRAPHIC
APPENDIX [U].

GUNS AND MOUNTS PHOTOGRAPHIC INDEX

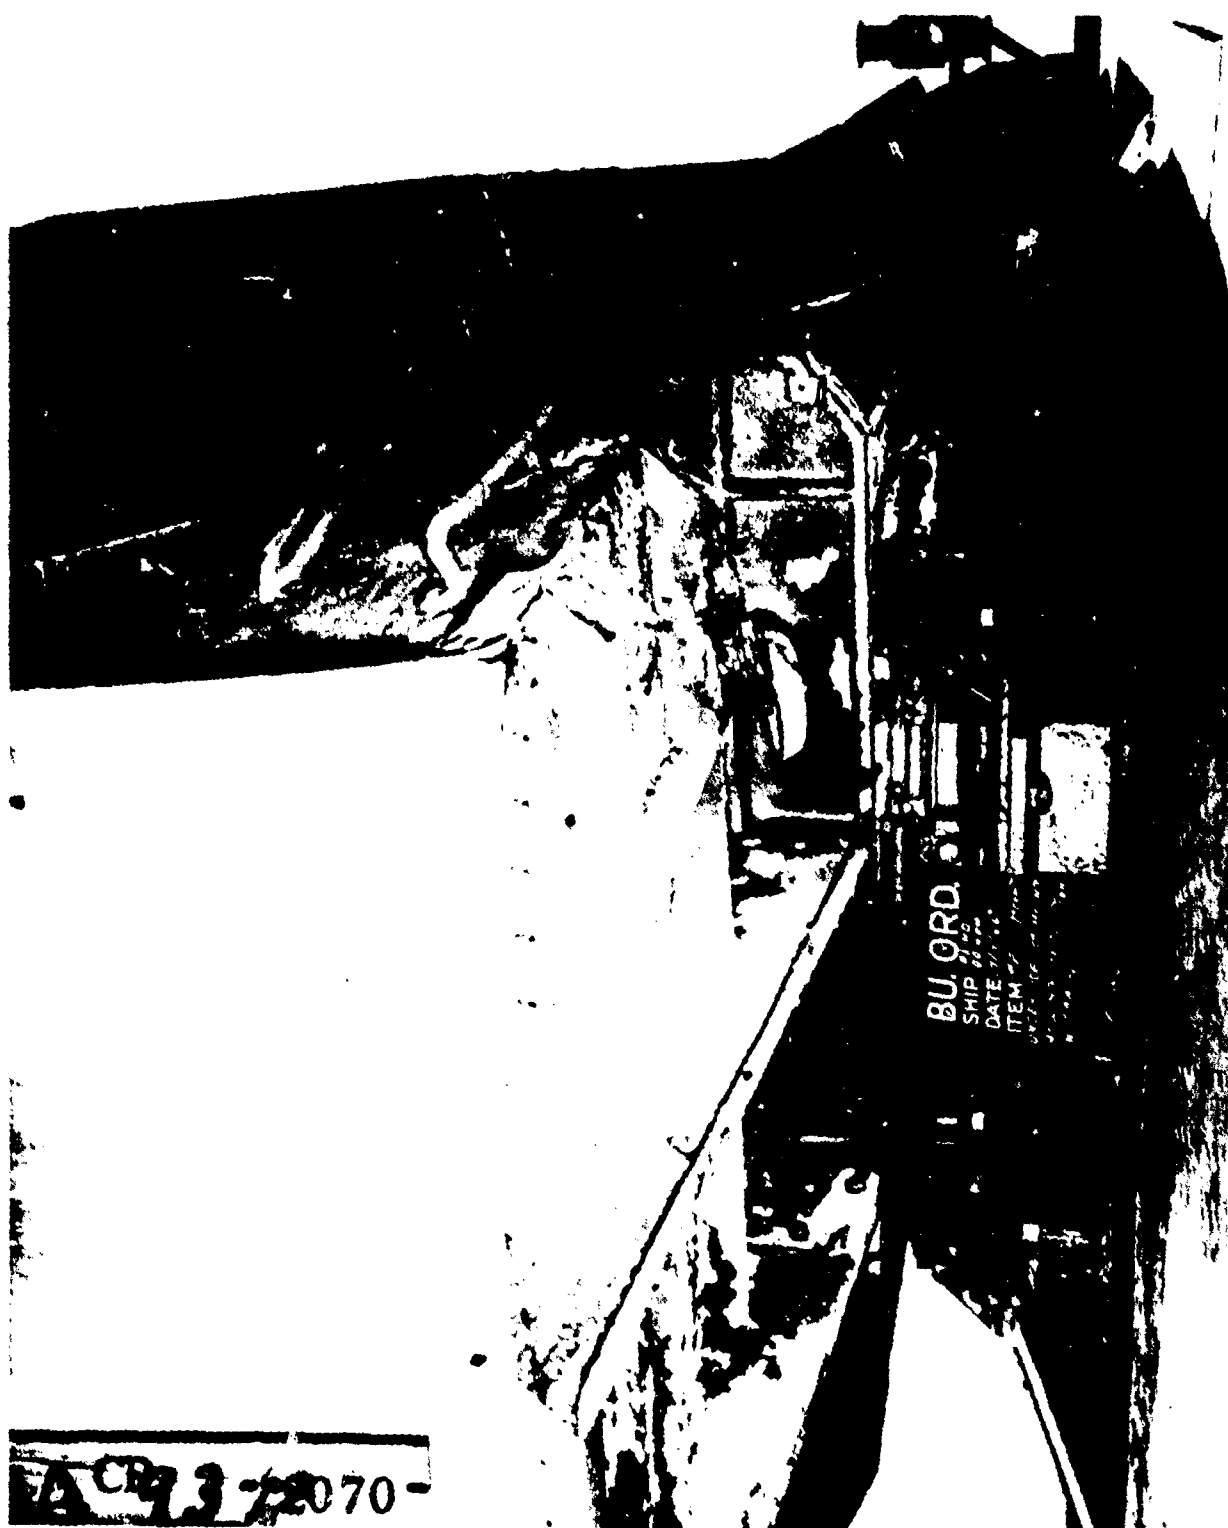
U.S.S. RHIND (DD-404) - After Able
 General view of the underside of
 5"/38 Mt. No. 2.
 Showing the scorched paint and the ruptured
 hydraulic sump tank. The "dishing in" of
 the shield can be seen.
 Photo. No. AA-CR-93-2070-7.

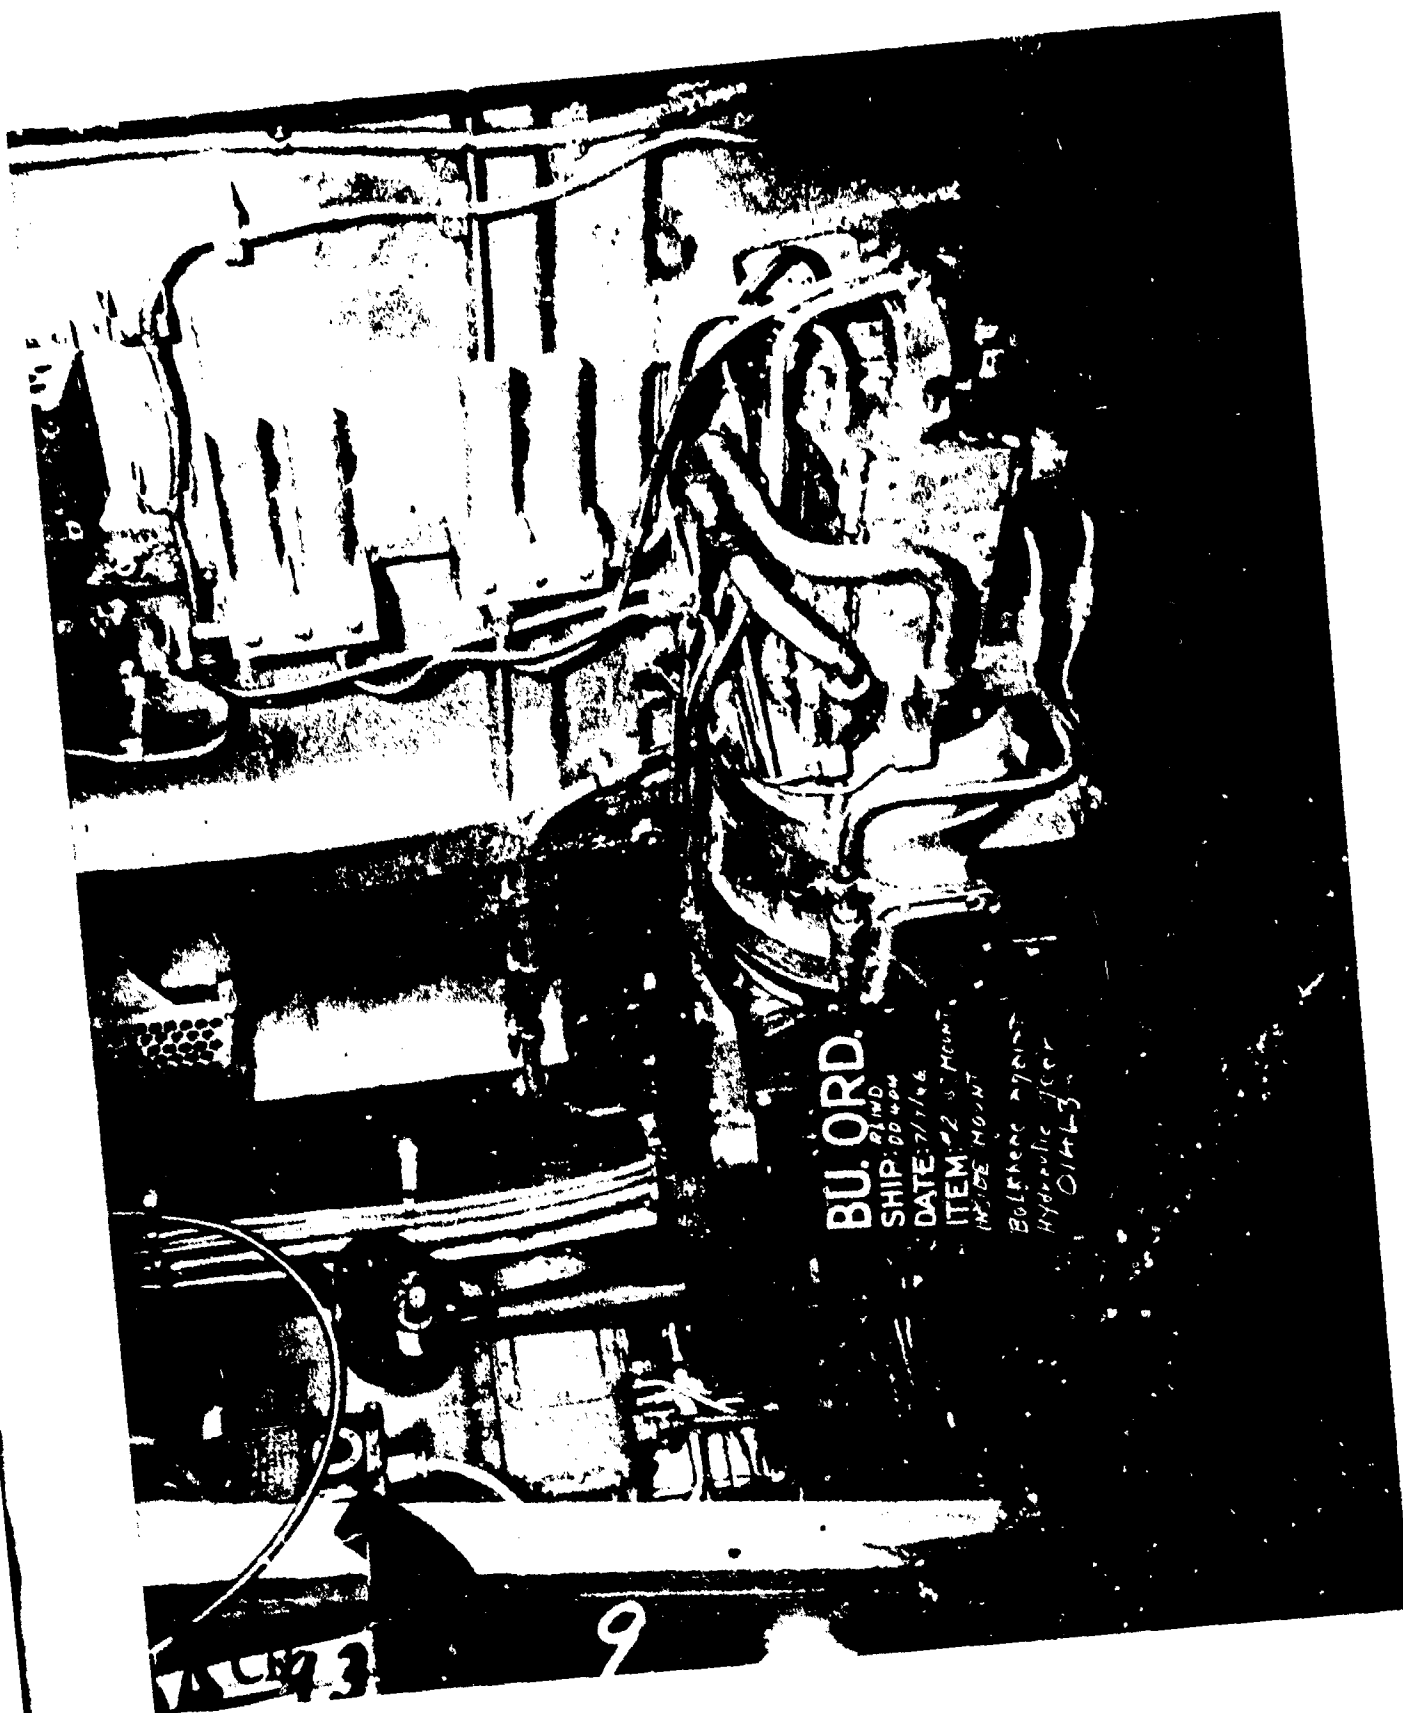
U.S.S. RHIND (DD-404) - After Able
 Interior view of 5"/38 Mt. No. 2
 Showing the "dishing in" of the starboard
 shield.
 Photo. No. AA-CR-93-2070-9.

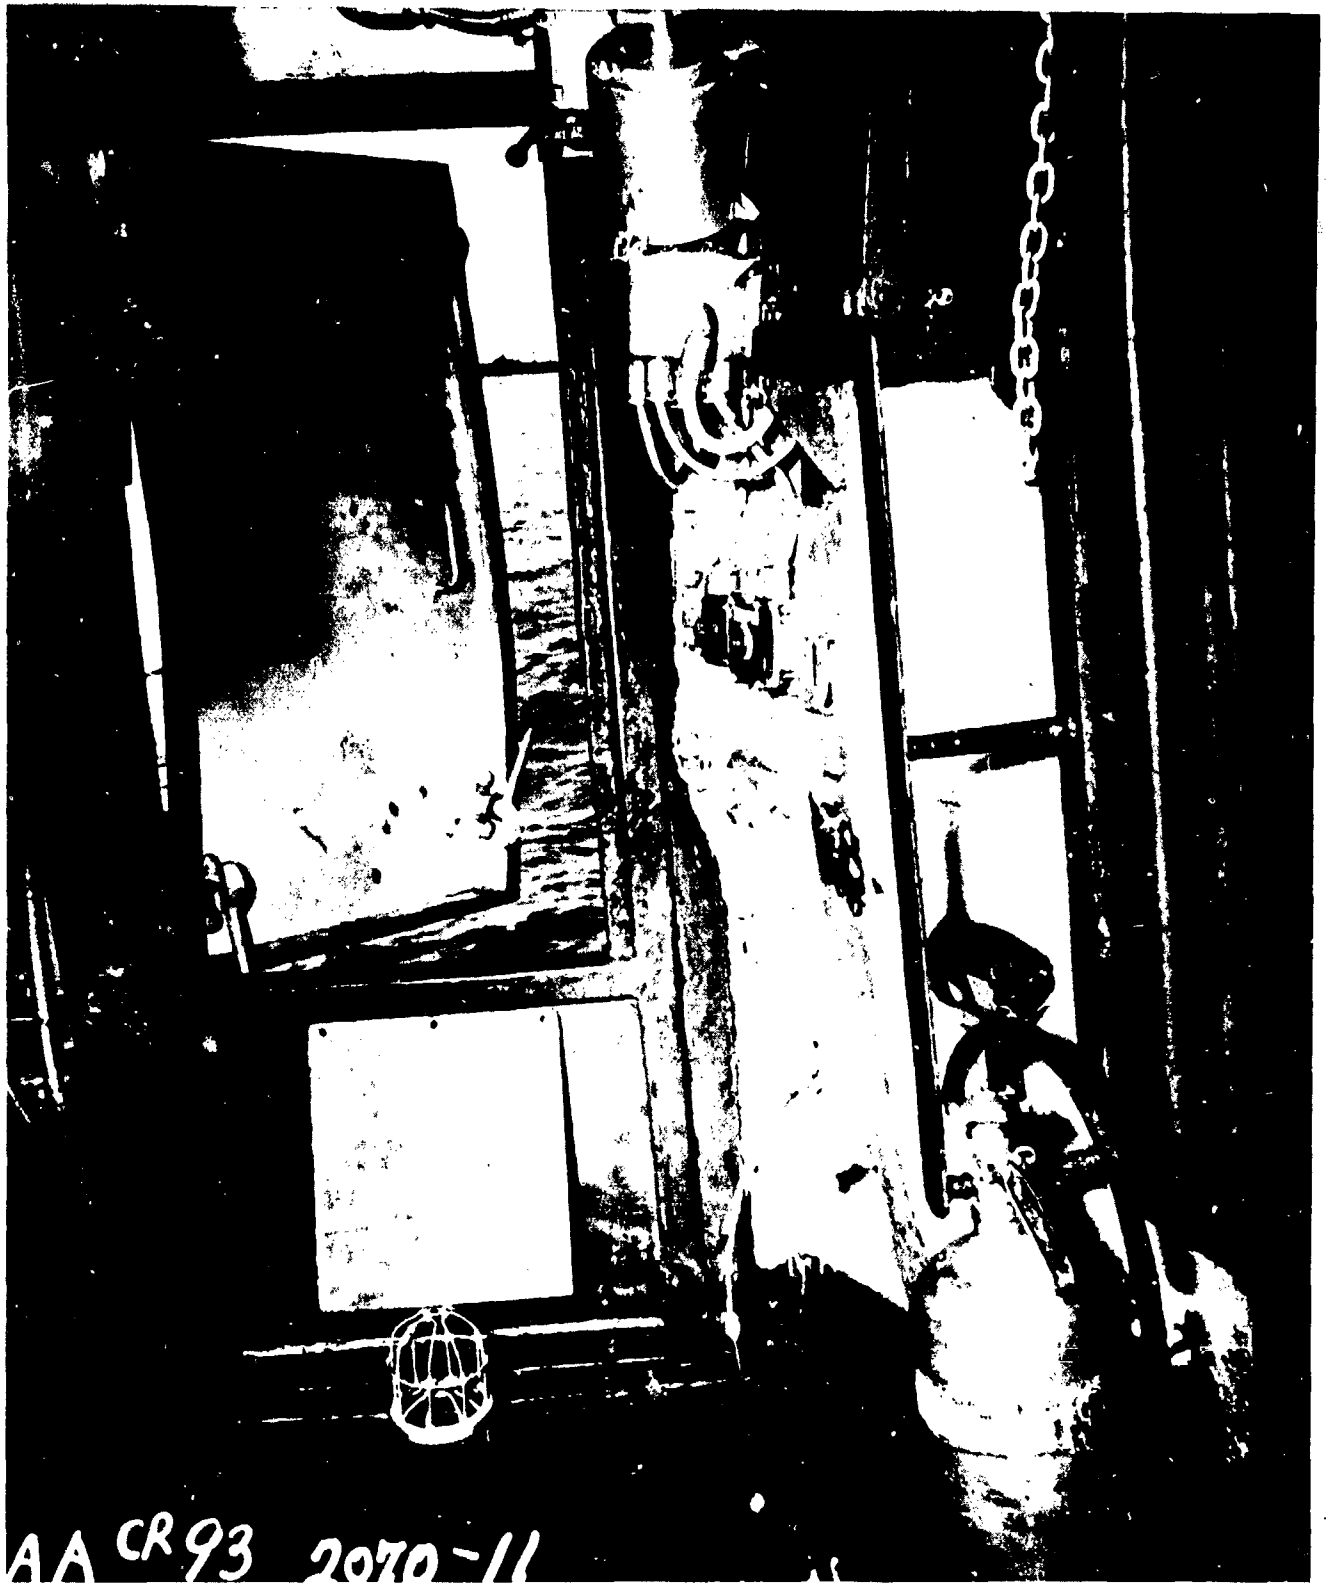
U.S.S. RHINE (DD-404) - After Able
Interior view of 5"/38 Mt. No. 2
Showing the "dishing in" of the
access door and after shield.
Photo. No. AA-CR-93-2070-11.

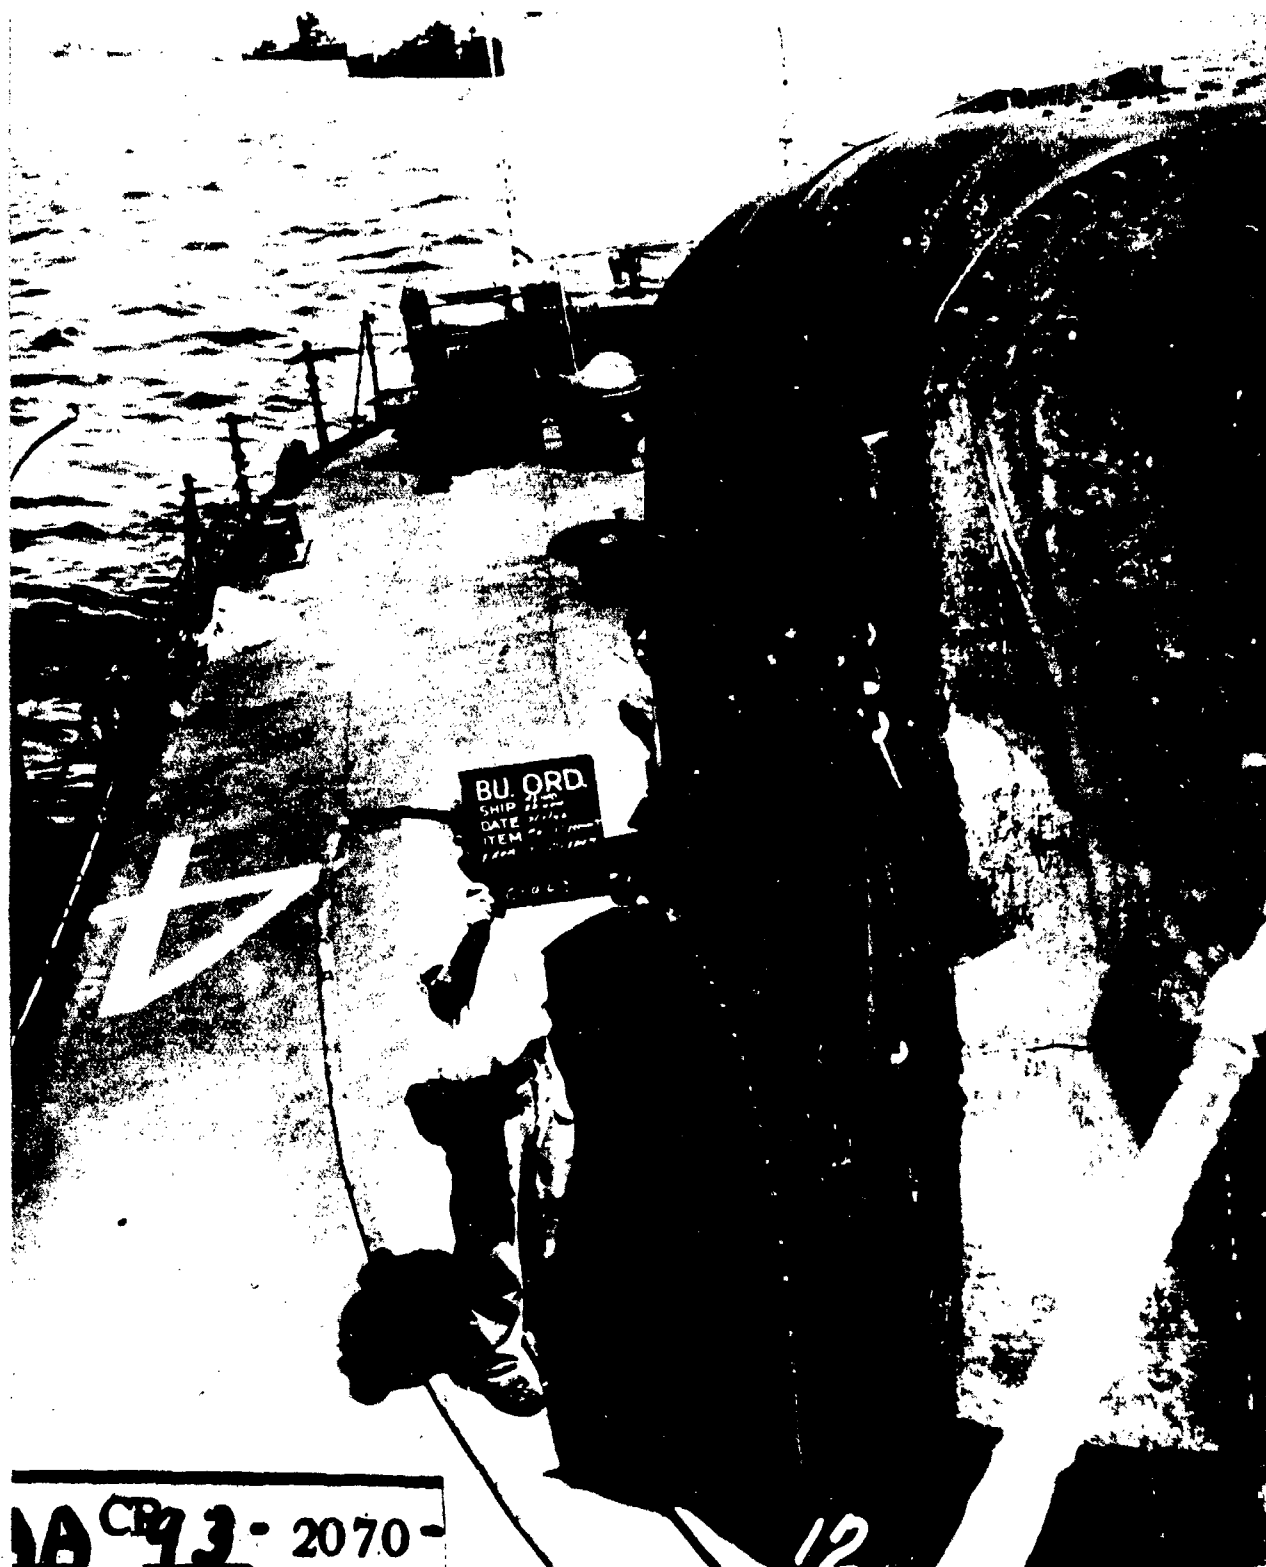
U.S.S. RHIND (DD-404) - After Able
 Exterior view of 5"/38 Mt. No. 2
 Showing the "dishing in" of the
 access door and after side.
 Photo. No. AA-CR-93-2070-12.

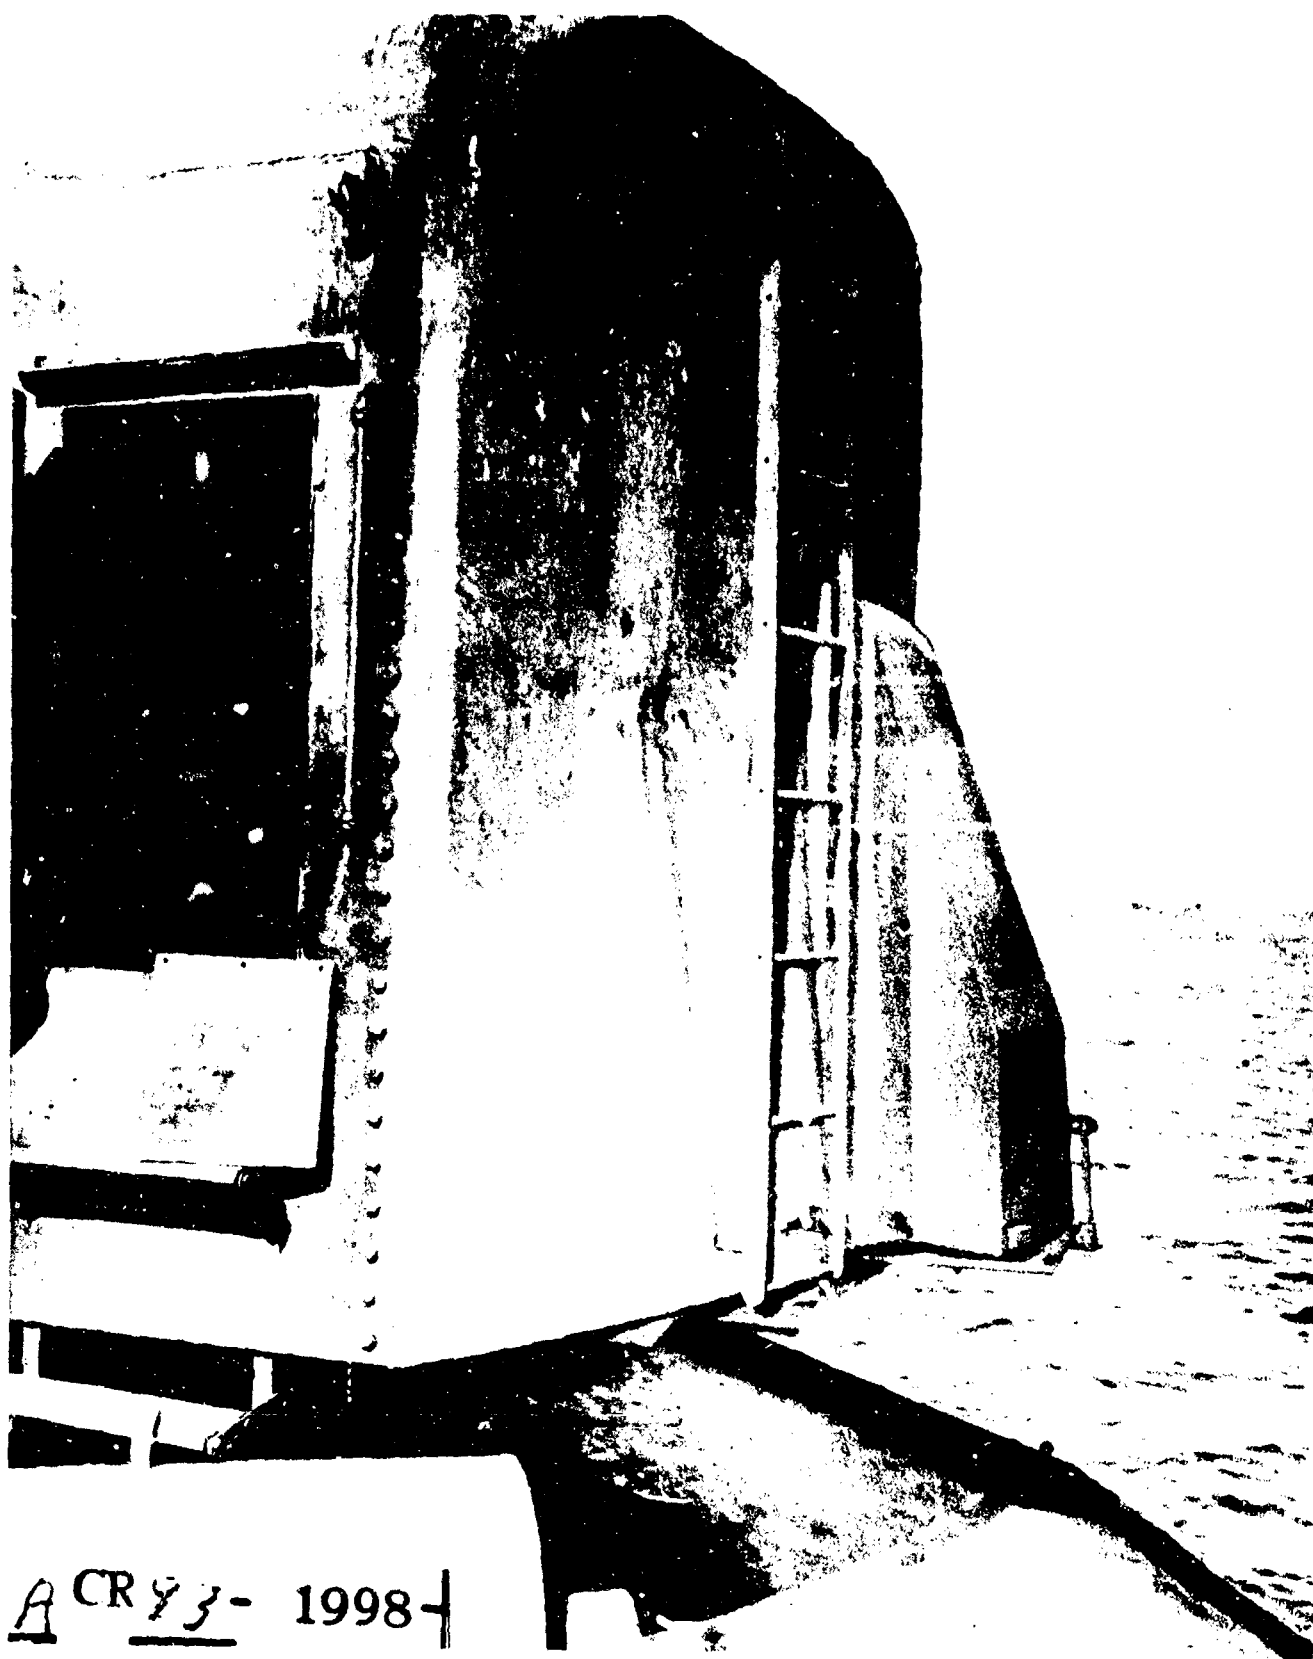
A CR 93- 1998-

U.S.S. RALPH TALBOT (DD-390) - After Able
Exterior view of 5"/38 Mt. No. 2
Showing the "dishing in" of the after shield.
Photo. No. AA-CR-93-1998-3.

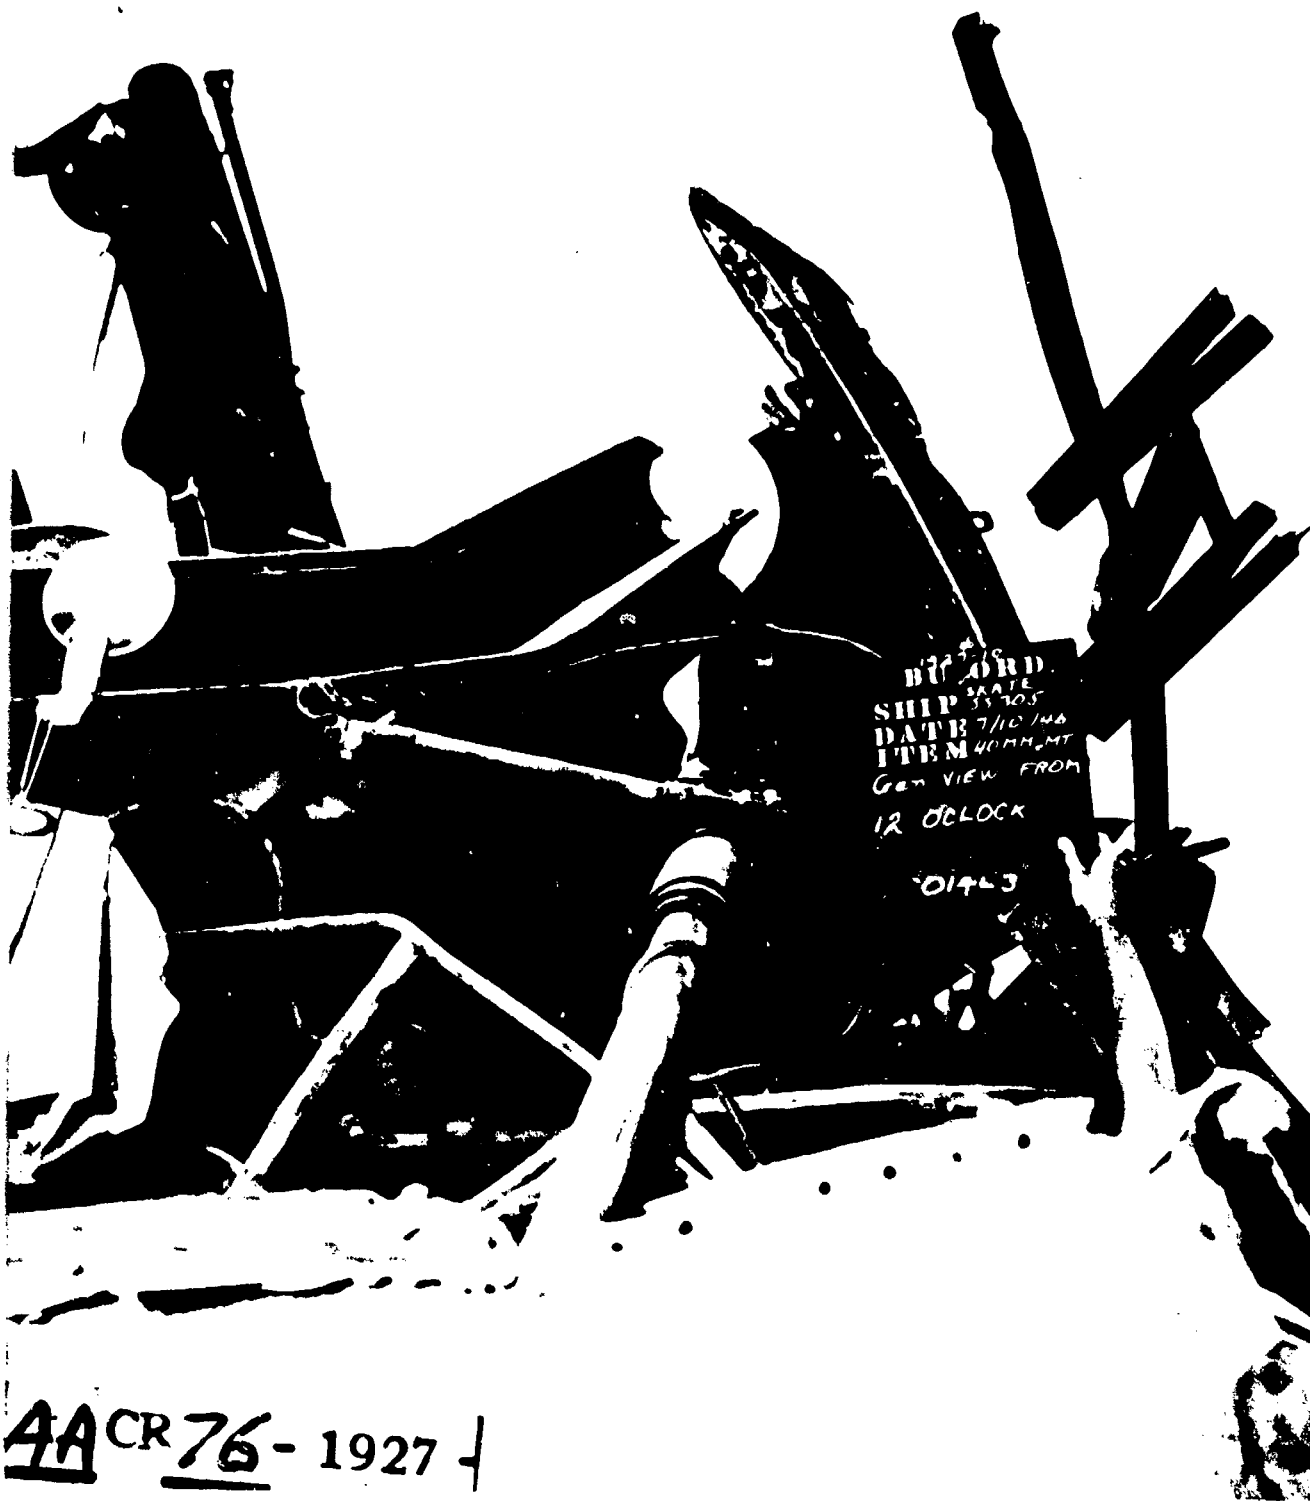
4A CR 76-1927

U. S. SHIP (33-305) - After Able
General view of the 40 MM Single Mt.
The gun mechanism, barrel and sight
bar can be seen.
Photo. No. 4A-CR-76-1927-19.

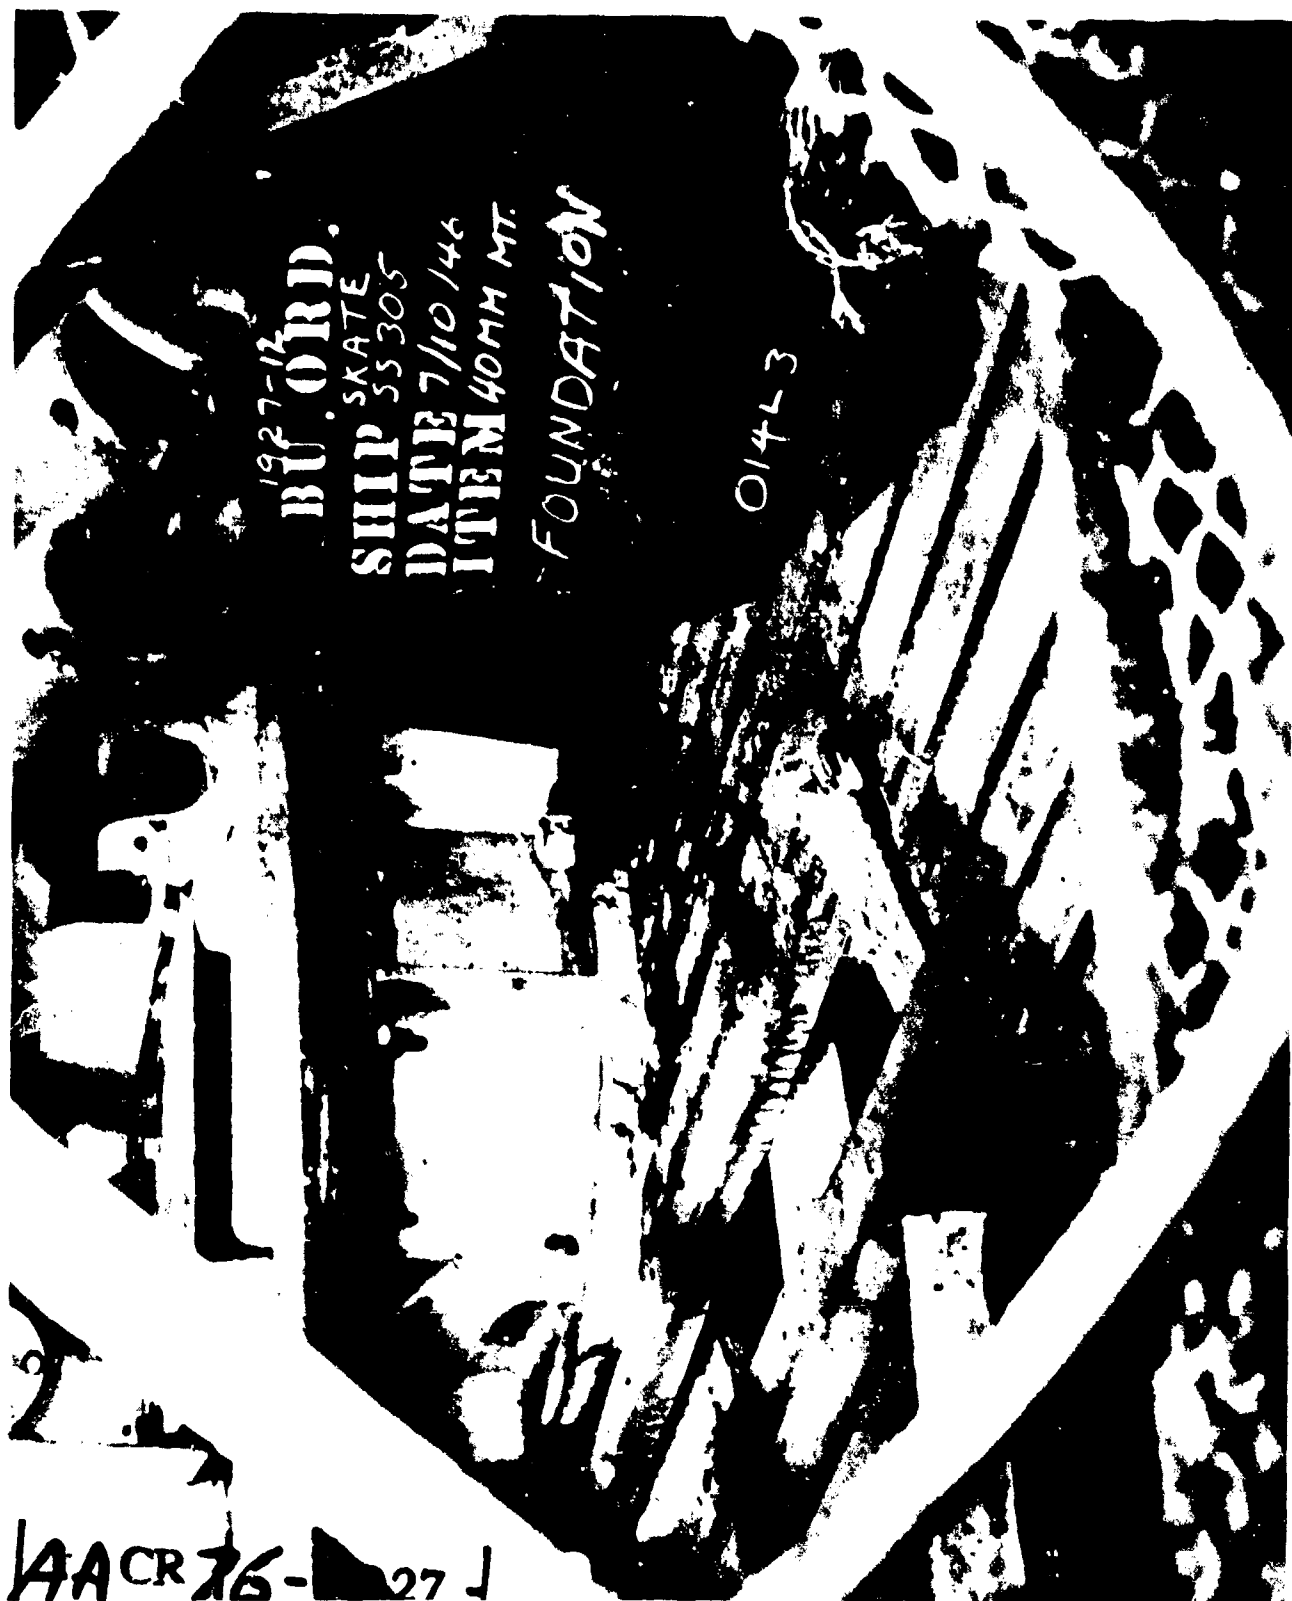
U.S.S. SKATE (SS-305) - After Able
View of 40 MM Single Mt., showing
the foundation intact.
Photo. No. AA-CR-76-1927-12.

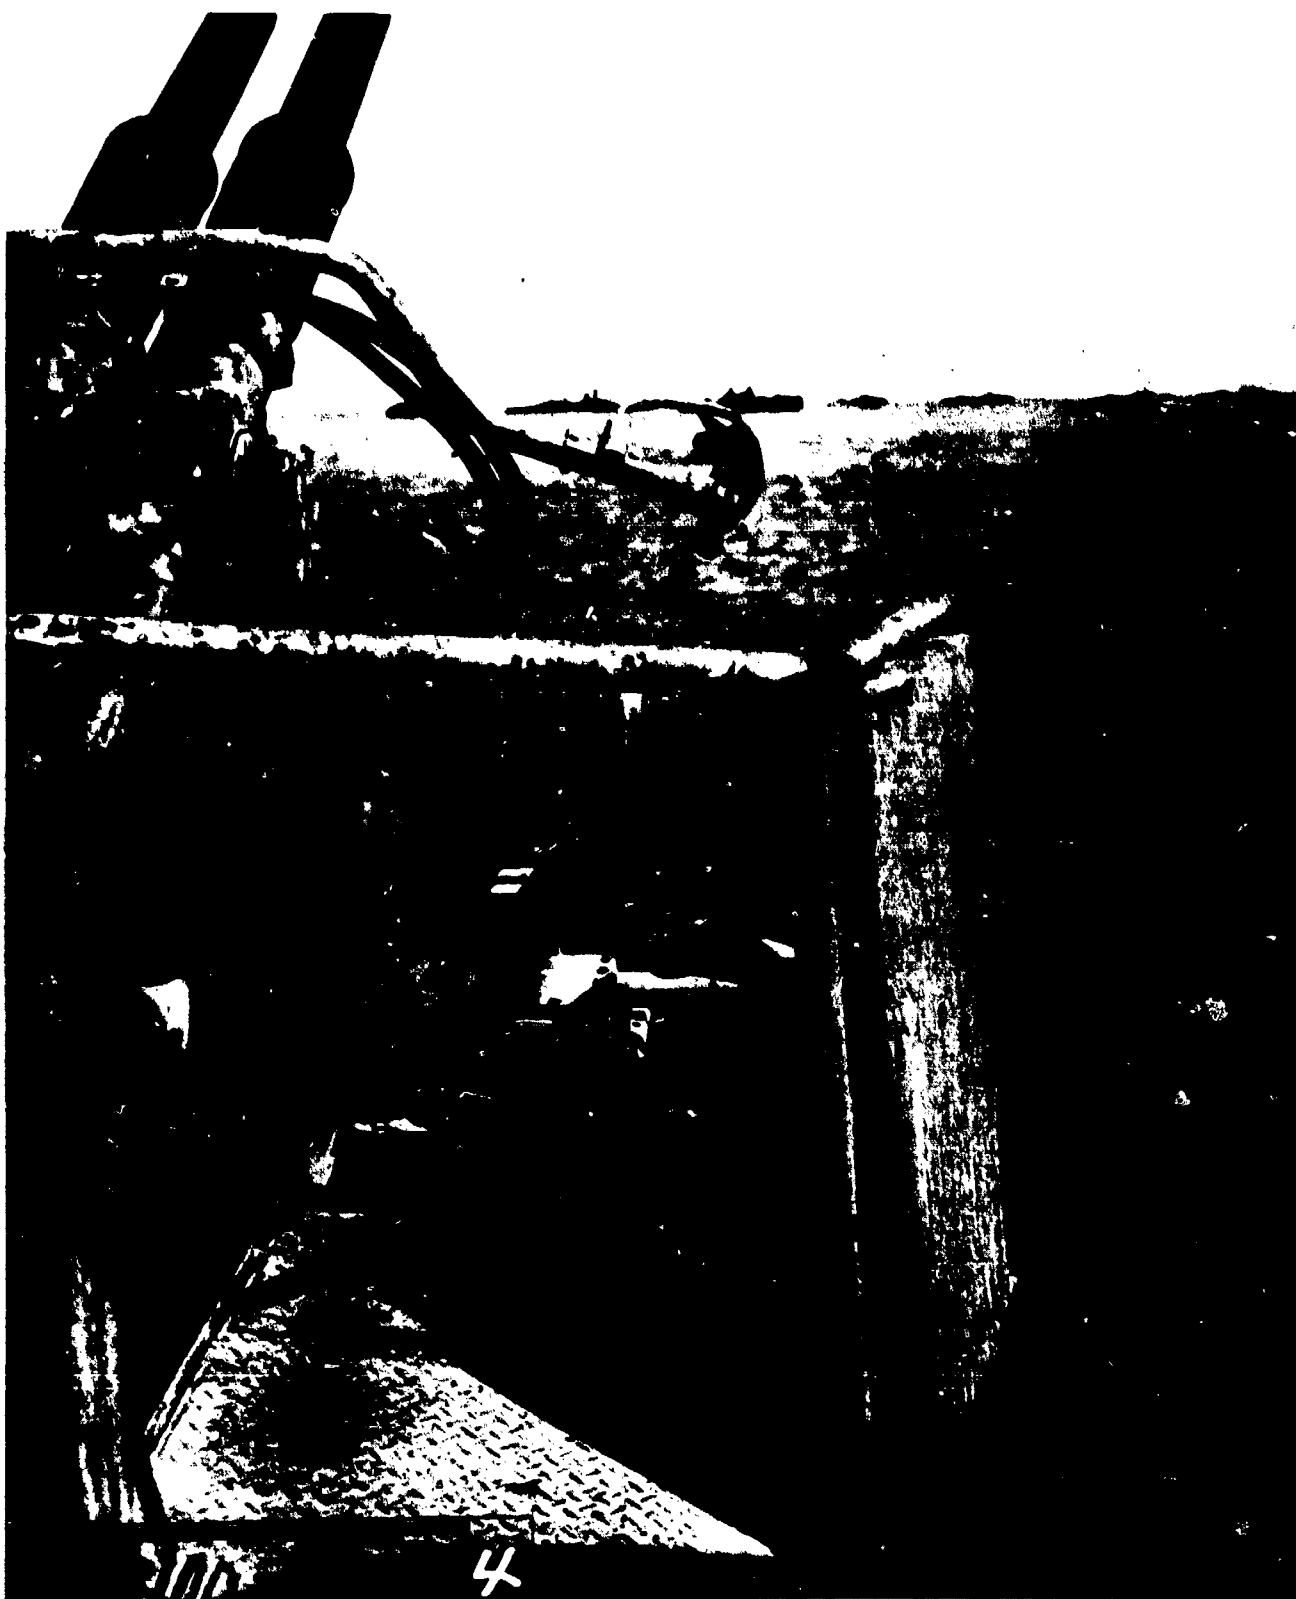
U.S.S. CALCORAL (ATA-85) - After hoker
General view of 40 MM, Mt., No. 4.
Showing distorted Gun Platform and bent
sight and sight bar.
Photo. No. 45-OR-100-4710-1.

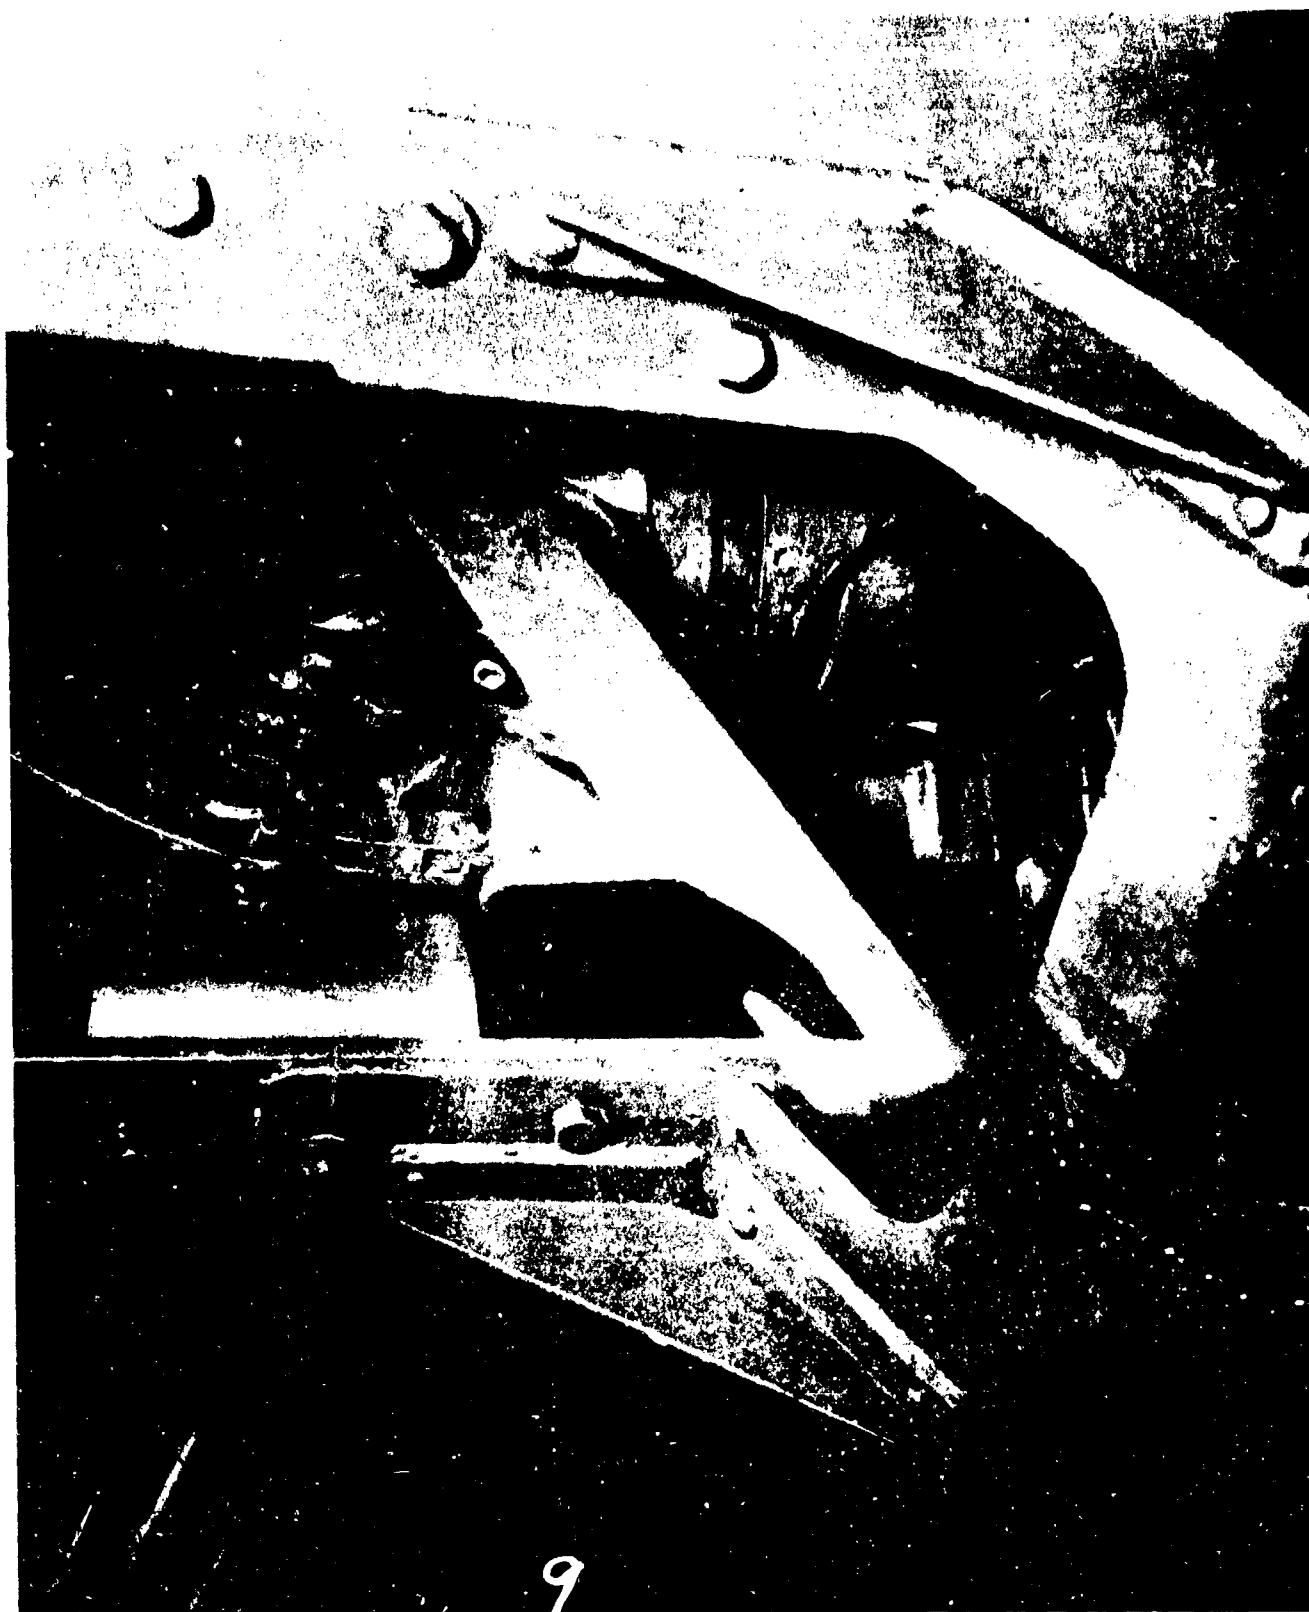
U.S.S. GASCONADE (APA-85) - After Baker
Close up view of 20 MM, Mt., No. 1.
Showing broken firing stop linkage.
Photo. No. AB-CR-100-4210-9.

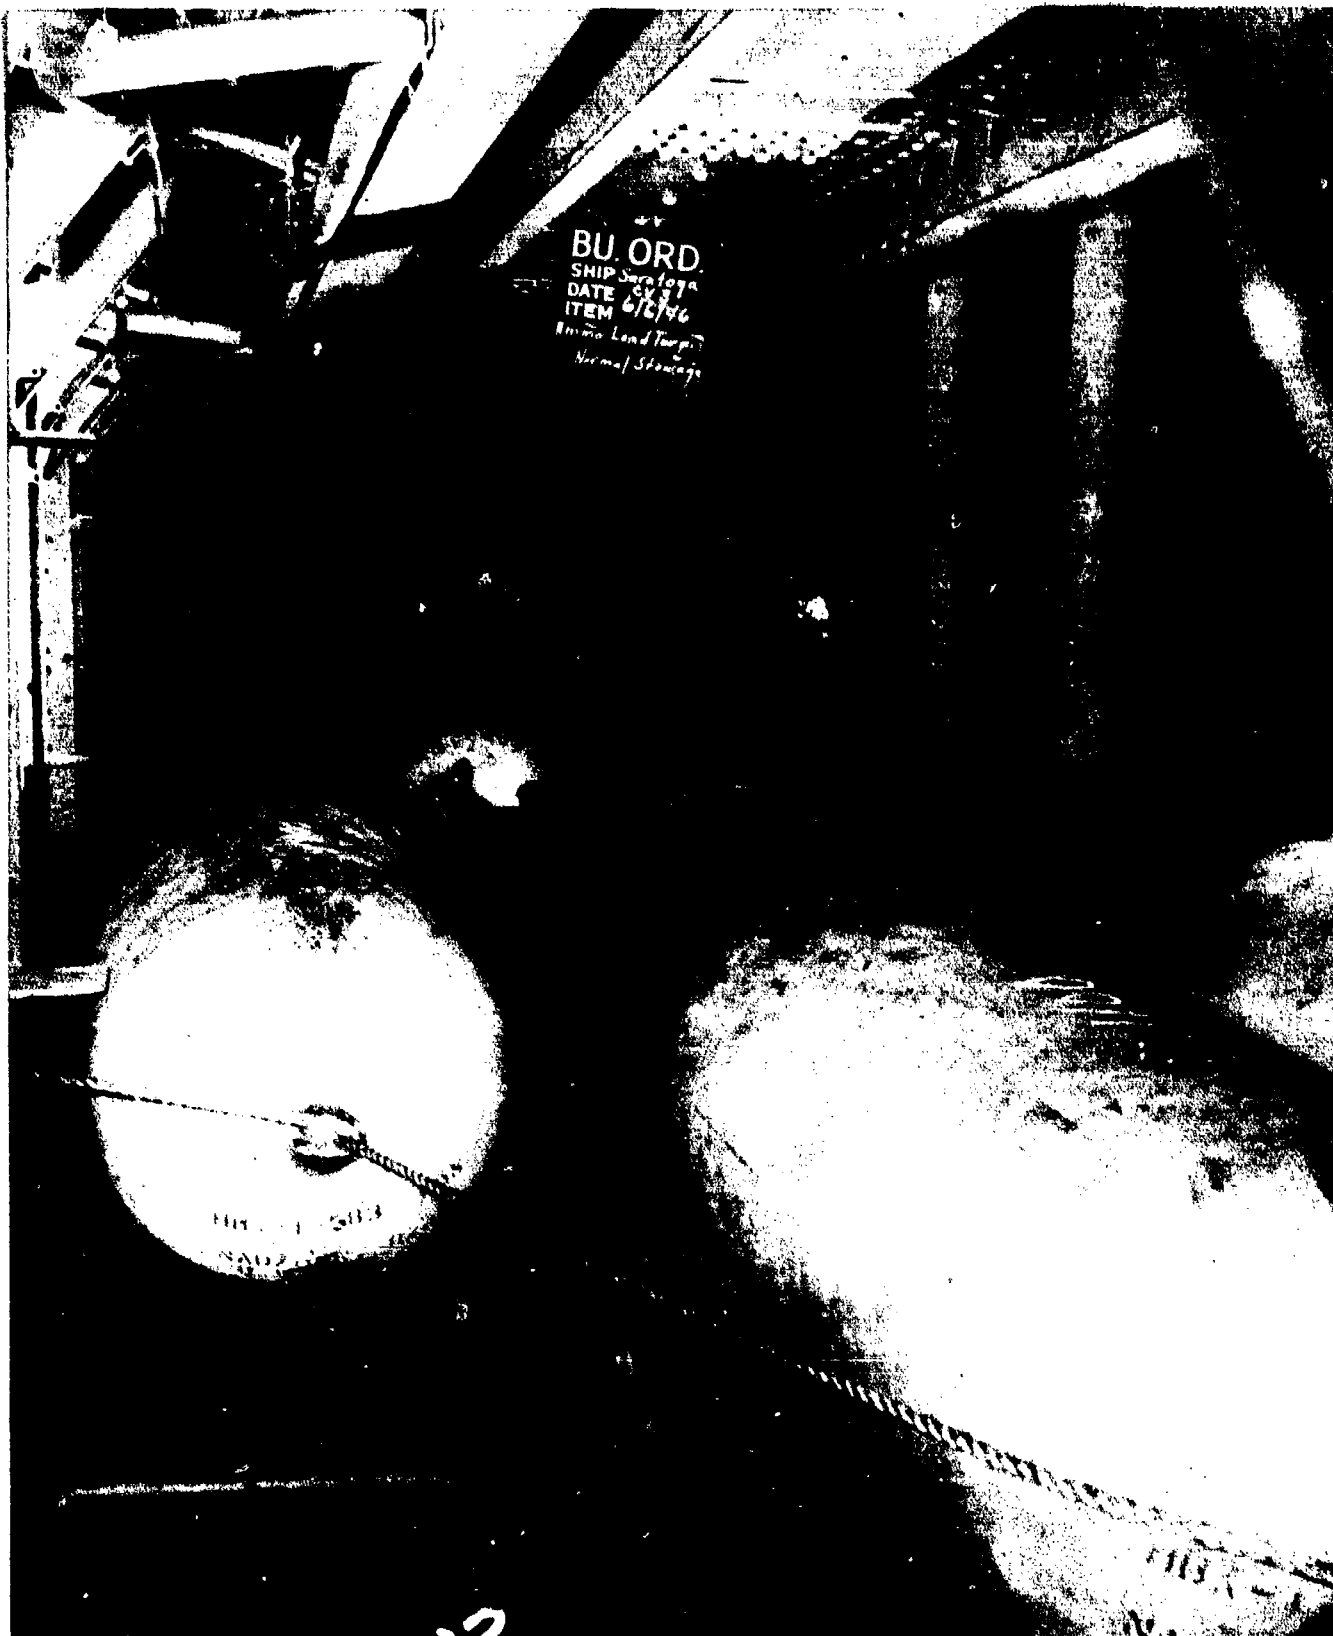
U.S.S. SARATOGA (CV-3) - Before Able
Service Load Torpedoes in normal stowage.
Photo. No. BA-CR-76-295-2.
